# Old Warden Review (RMF)

March 2018

Project Name: Old Warden RMF  
Project Number: 196307  
Report Title: Old Warden Assessment  
Report Number: 001

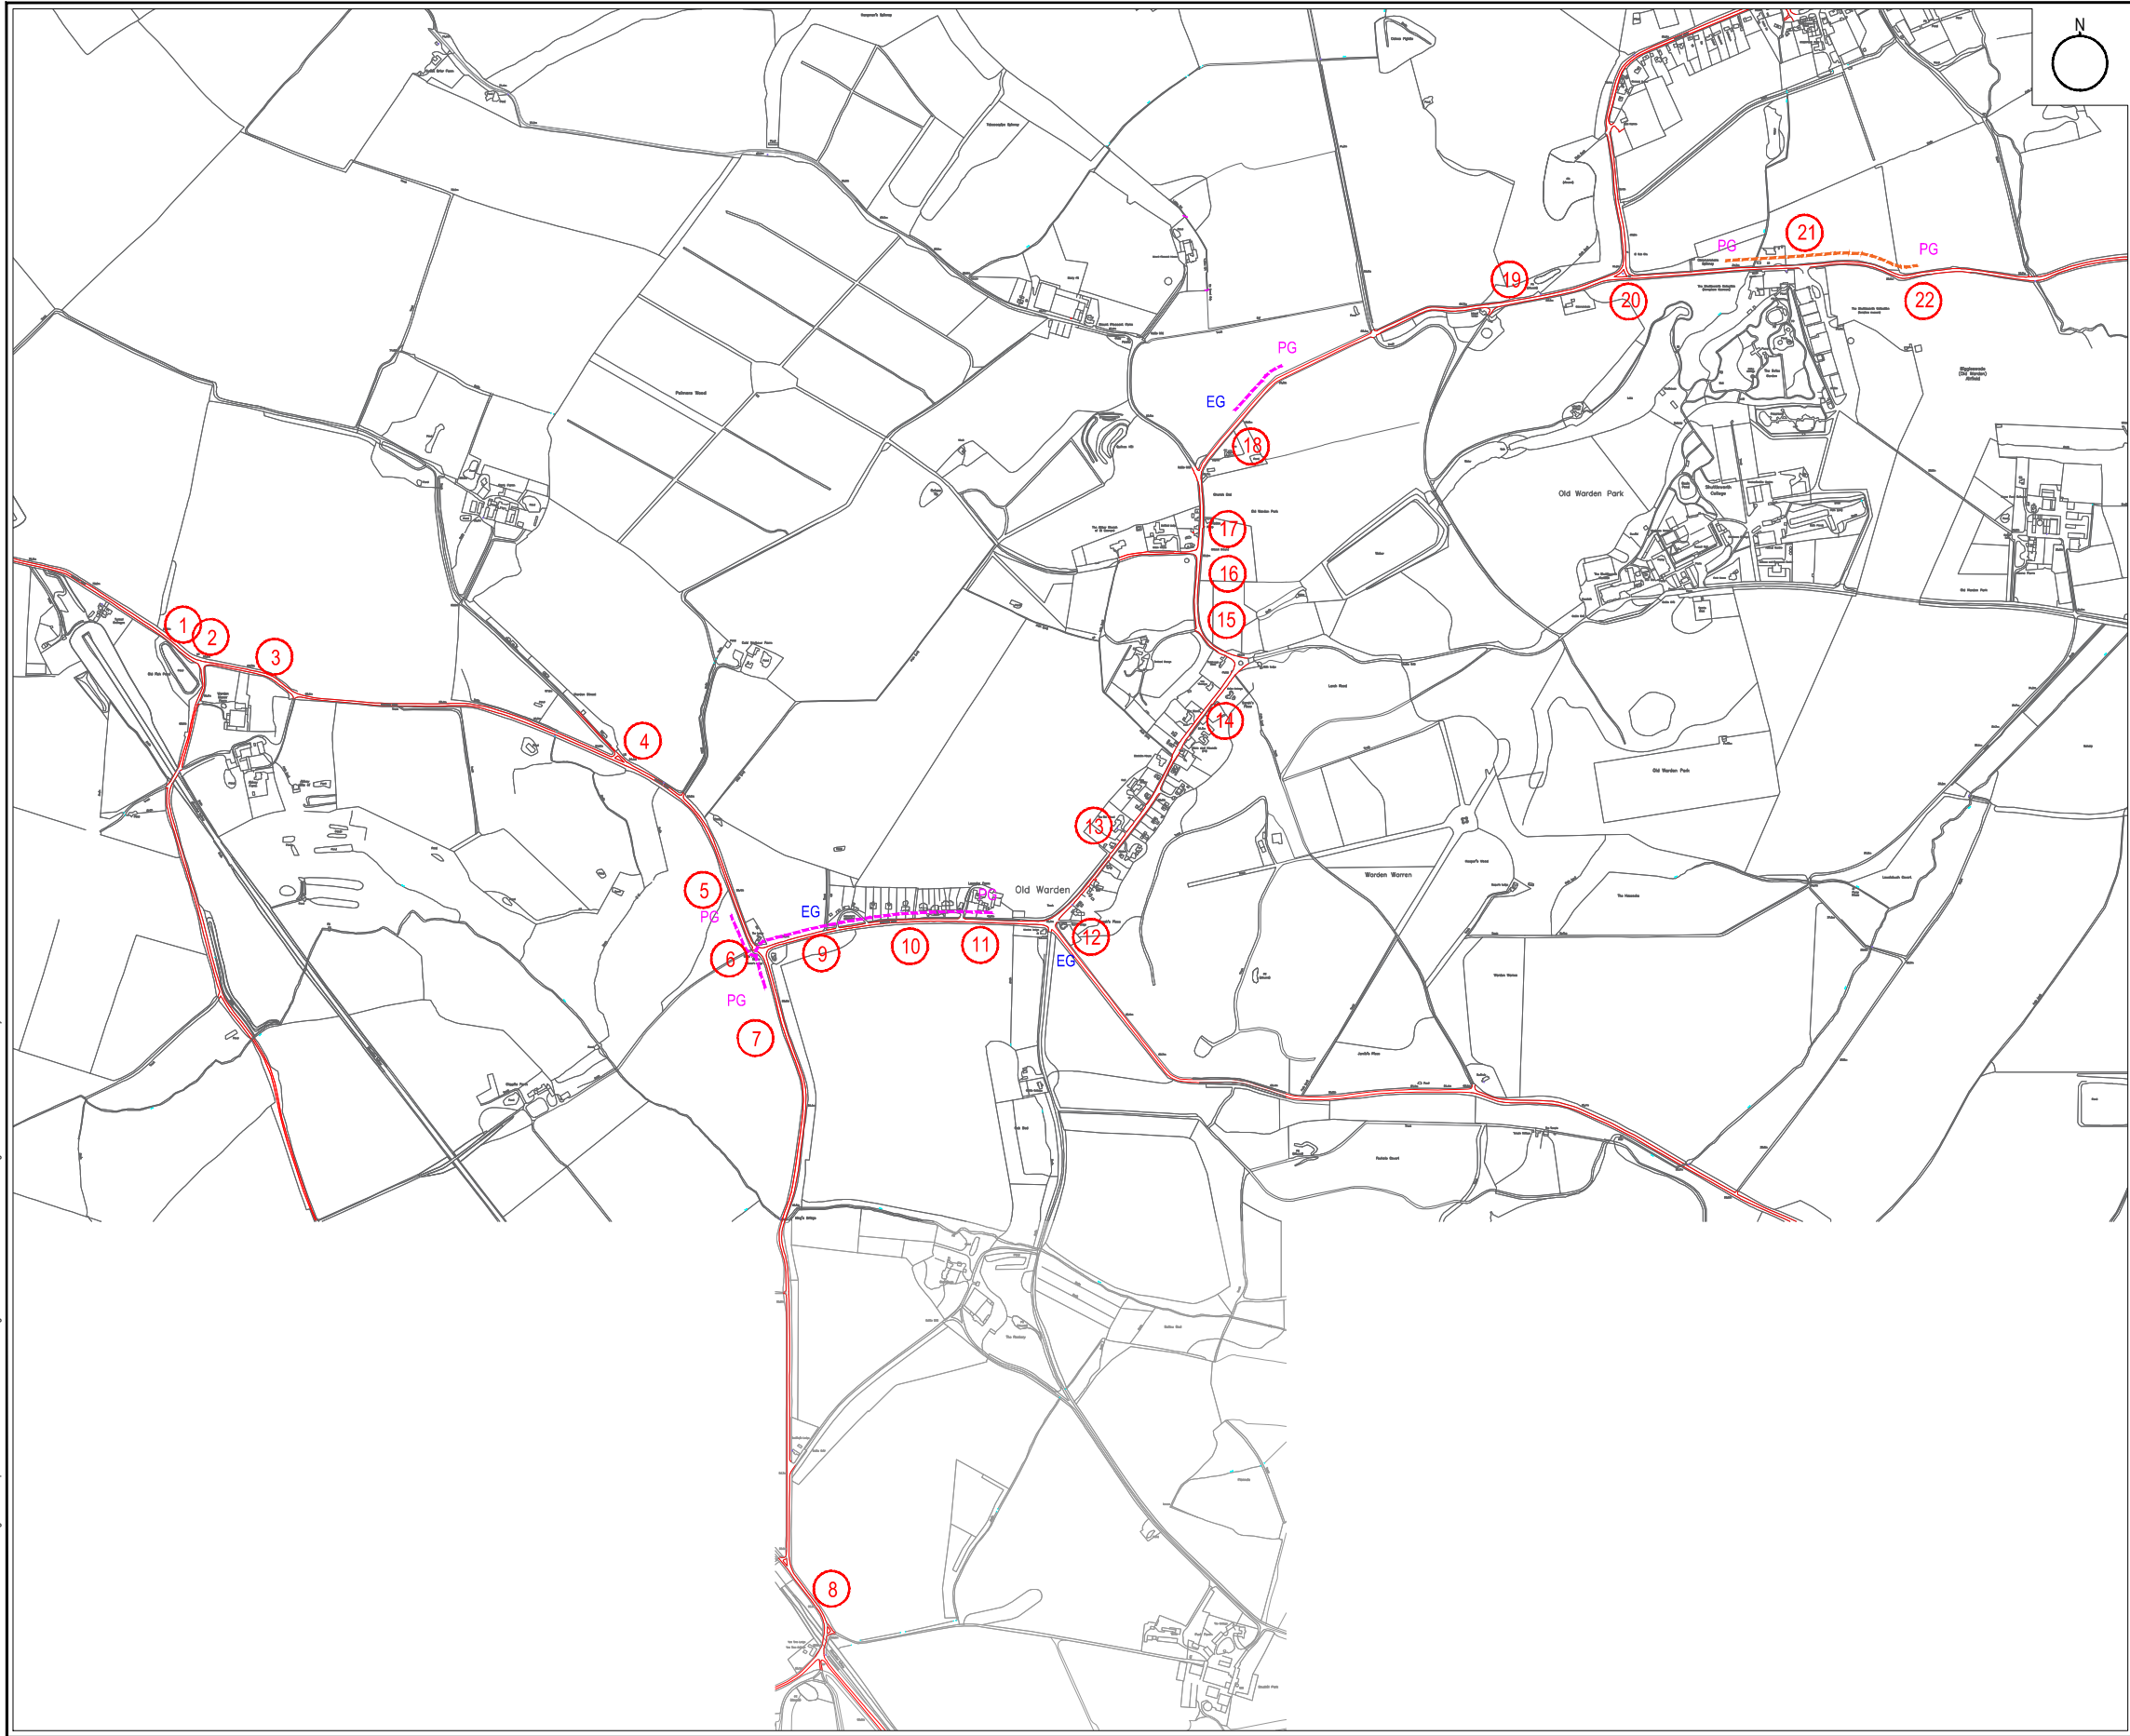
## Appendix B

For information on the proposed work to the road signage in and around Old Warden, see the attached spreadsheet (Appendix A) and location drawing (Appendix B). This is broken down into 22 locations across the parish.

The most complied with speed limits are ones that are readily appreciated, understood and respected by the motorists and therefore essentially self-enforcing. Possible gateway locations are highlighted in **Appendix B**.
